# Manhole Inspection Summary

Manhole # S27E\_\_063MH

Insp Date: **8/24/07 9:33 AM**

**Location** Address: **126 AMITY ST**

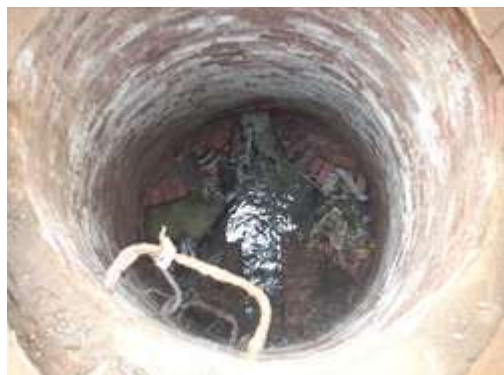
Top View

Comments **ALOT OF CHANNEL DEBRIS DISRUPTING FLOW**

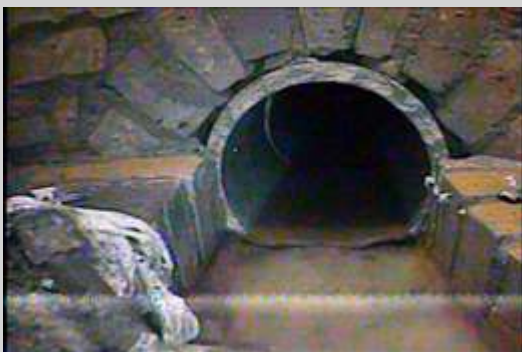
9 O'Clock Inflow

Pipe In @ 9 O'Clock

Pipe Height: **8.4** (in.) Rod and Bar (Angled)

Infiltration: **None** Pipe Seal Cond: **Sound**
